# **Study of Deterioration of Court Floor of Sultan Hassan Mosque in Cairo**

**ABSTRACT:** The college- mosque of Sultan Hassan is considered one of the finest examples of Islamic architecture not only in Egypt but also in the East. Its open court is paved with different types of marble. These marble slabs suffer from severe deterioration. Causes of this deterioration were determined accurately through the ocular examination of the court and confirmed by the laboratory tests which were carried out on samples representing the three common types of marble used in the floor namely the white, the red and the black marble. Sun light and heat are the main deterioration factors and the consequent thermal expansion is the main property which led to the detected deterioration phenomena.

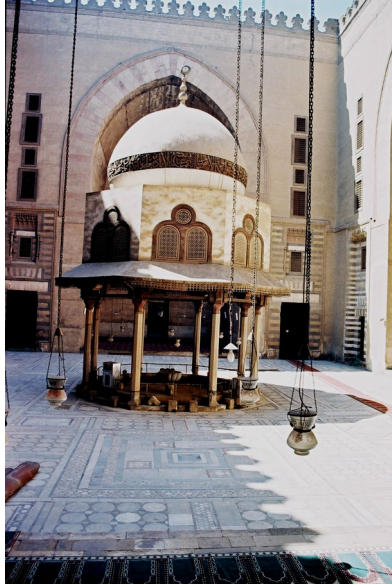
It was built in 757 A.H. – 1356 A.D. by order of Sultan Hassan on a rock below the Citadel. Its interior is divided into four large halls (iwans) with lofty barrel vaulting surround an open extensive court (sahn) (the studied part) (Figure 1) which is paved by marble slabs of different colors. The biggest of the halls is situated to the east and is decorated with a frieze cut in stucco with fine Kufic letters from the Qoran on an artistic background of arabesques. The rear wall, with the prayer recess, is adorned with marble. The square domed apartment has an interesting inscribed frieze of carved wooden letters from the Qoran. The ceiling and the painted frieze have been partly restored <sup>[9]</sup>.

**Figure 1:** General view of the studied open court.

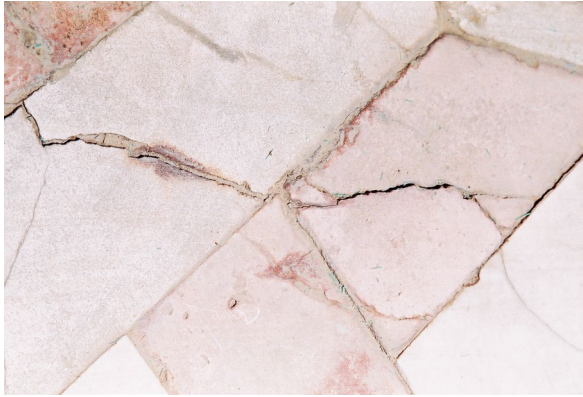
An overall discoloration and colors reduction of the black, red and white marble slabs which represent the most common colors in the floor of the court; were observed. The discoloration was observed in the white marble slabs which have altered to slight yellow color while the color reduction took place in the black and red slabs (see Figure 2).

Cracks appear in the all kinds of marble which extend within the cleavage plans and the weakness levels between the crystals (see Figure 2).

**Figure 2:** Discoloration and color reduction in the white and in the red slabs respectively and cracks extensions in both of them.

The discoloration and colors reduction are due to the light of sun and the all other determined deterioration phenomena are due to its heat.

The author attributes the discoloration and the reduction of marble colors to some photochemical reactions especially in the accessory minerals which play the main role in producing the marble color during its geological formation and before its using and incorporation in the archaeological building.

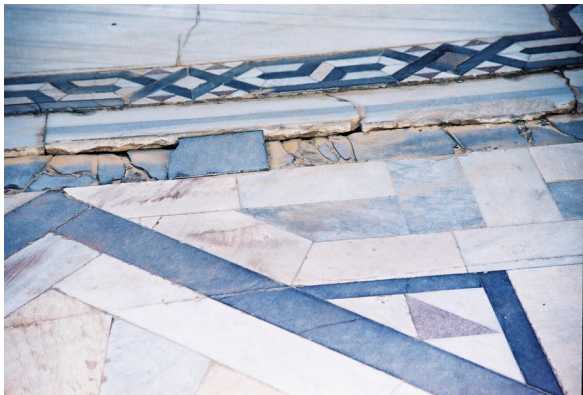
Much of the mortar of the setting-bed and of the joint had lost its cohesion and as a direct consequence detachments took

place either between the slabs themselves or between the slabs and the statumen (the stone blocks) or both of them as shown in (Figure 3).

**Figure 3:** Mortar of the setting-bed was altered to powder and dispersed on the surface of slabs causing their detachments.

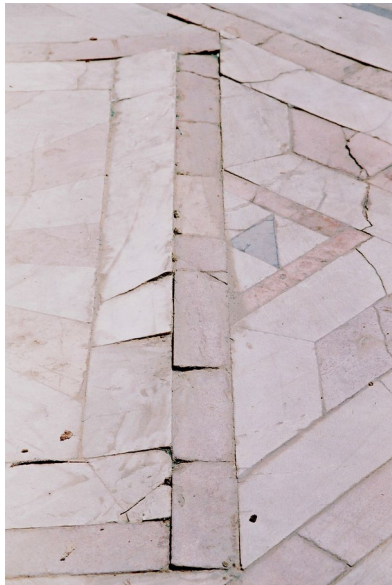
Many slabs are not uniformly flat where a hump running the entire length of the north side of the court. It was observed that the deformations which affect the marble slabs vary between slight and severe degrees therefore and as a consequence of this variation; different types of deformations were produced.

The final result of marble slabs deformations is their complete detachment from the statumen (see Figures 4 and 5).

**Figure 4:** General view of the severe deformations which affect the marble floor of the court.

The author attributes strongly the all deformations types of marble slabs in the studied court floor to the thermal expansion and not to the moisture expansion because the ocular examination proved that no deformations were found in the marble slabs around the fountain centralized in the court which is used up till now for washing (wdoa) before every prayer as shown in (Figure 11).

The expansion and contraction because of the change of temperature cause serious movements in the floor structure and

if a slab is restricted between other slabs and joints neatly with them they cause stresses resulting in deformations and cracks.

The author recommends do not leave the court of the mosque continuously open especially in the summer season in order to avoid the very serious effect of the sun light and heat on the marble floor. Such this recommendation can be achieved by using mobile shelter which can be opened and closed at the suitable times according to the temperature degree.

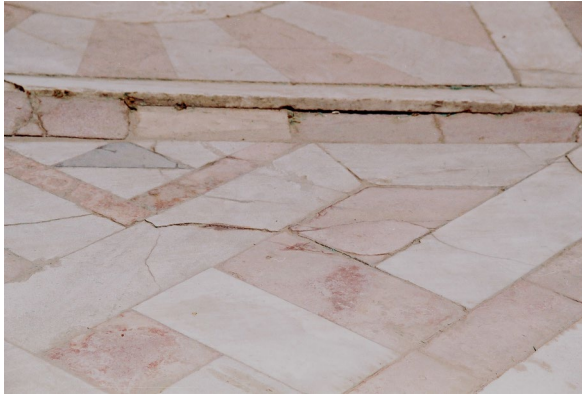
**Figure 5:** Detail from the last figure from other angle.

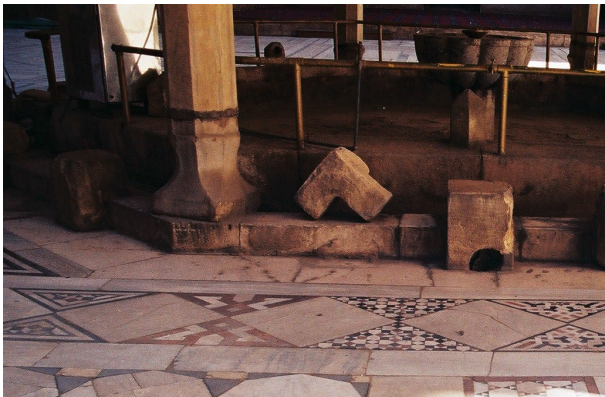
**Figure 11:** The slabs which are around the fountain and always exposing to the water do not suffer from any deformations produced by expansion.
