## **ISLAMIC ART AND ITS EFFECTS ON THE ARTISTS OF THE MODERN ART MOVEMENTS: APPLICATION ON THE MURAL PAINTINGS ON THE KRABIA SCHOOL IN CAIRO – EGYPT**

#### ***Archaeological history of Krabia School***

### ***Architectural Description of the Krabia School***

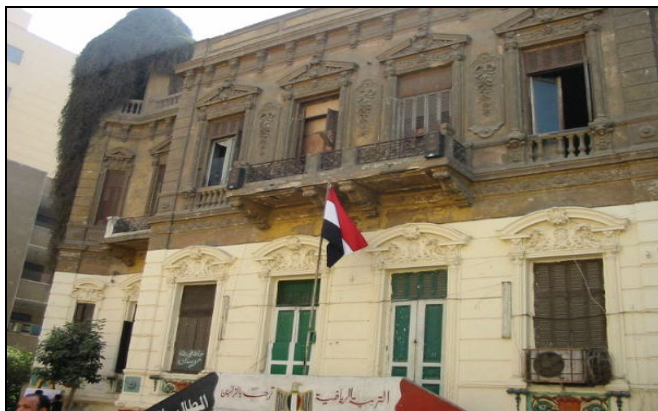
Figure1: The outside view of Krabia School in El-Shech Rehan Street in Cairo.

The plan of the school consists of a basement and two interchanges floor (fig.1). The first floor: can be reached after ascending ladder that leads to a rectangular space—Portal-REO—that sheds two rectangles, each side room opens in this space and it has the main entrance of school which leads to a great rectangular hall that has the openings of all units on the first floor. The architecture opened six entrances at this hall, three entrances to each side. The first and the second entrances of the right side lead to two rectangular halls, and the third one leads to the bathrooms. As for the three entrances on the left, they lead to rectangular halls. The great rectangular hall ends with the stairs leading to the second floor. The second floor leads to a space that has two entrances on each side. The right entrance leads to a rectangular Hall, and the left leads to a Hall above the baths on the first floor. In the front of the ascending on the stairs there is a middle entrance leading to a large rectangular hall—located above the large hall in the first floor of the School—to which six entrances open leading to the rectangular rooms. It was noted that, the school has large openings, doors, and windows and this undoubtedly is related to the magnitude of this architecture.

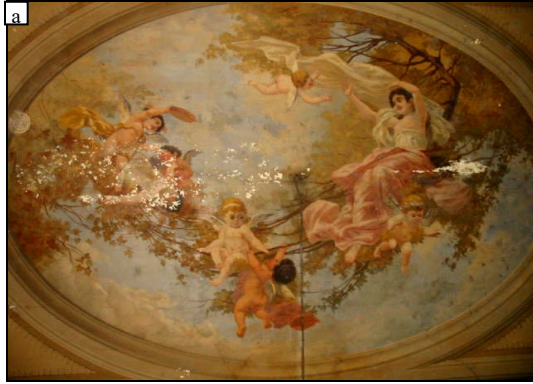
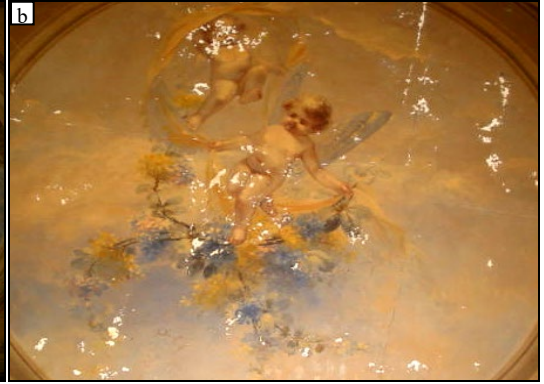
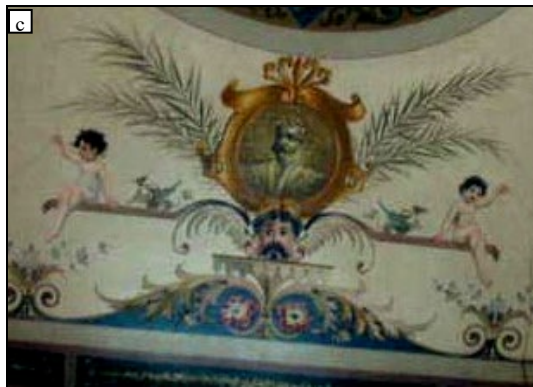
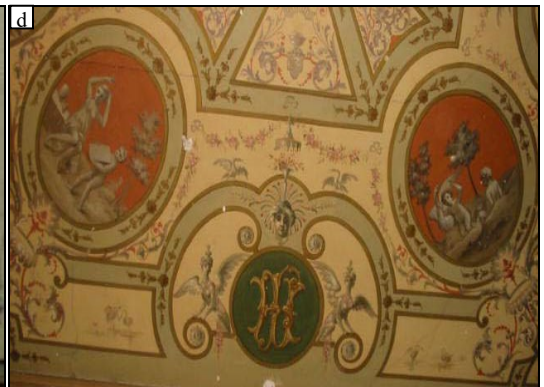
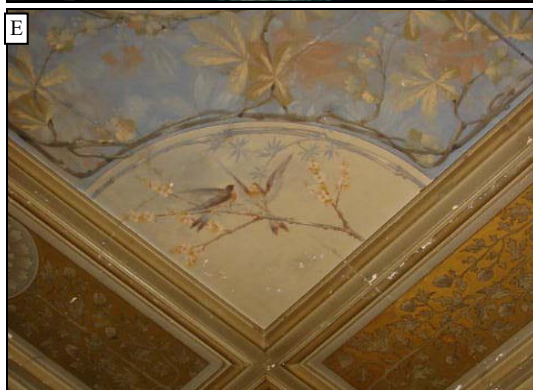
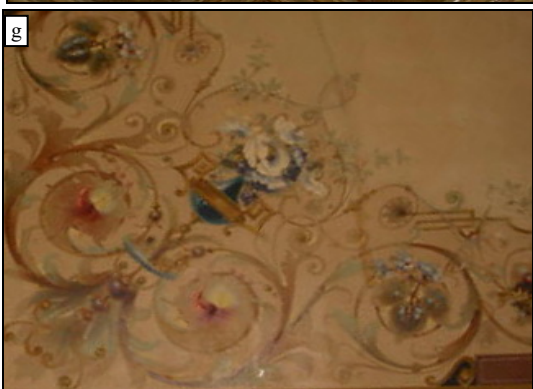
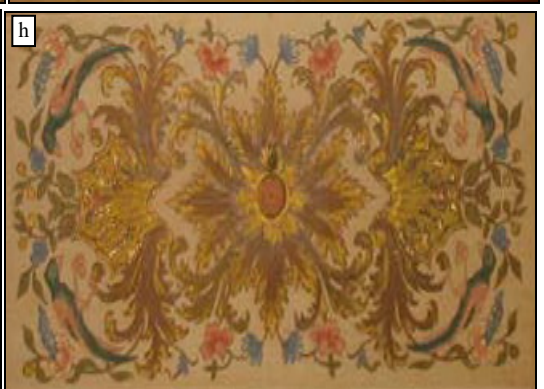
Figure: 2 details from the wall paintings decorated the Kerabia School

Ceilings are one of the most important architectural elements in the architecture especially in Egypt. It was not only used for structural purposes but it was widely used to add aesthetics and creativity in terms of the building. The ceiling is the prominent part of the Krabia School and decorated with multiple ornaments in various colors. The ceilings of the rooms, halls and some walls of Krabia School were originally prepared to receive mural paintings with the application of two plaster layers which decorated with amazing paintings, which showed the effects of Islamic art in European artists. Wall paintings have some diversity in the context of the decoration. Units and decorative items were multiple in the ceiling: beauty and the love goddess "Venus" (fig.2a), children of love "Kiobid" (fig.2b), an old man with a mustache and beard (fig.3c), figurative human drawings painted in the third room to the left of the main entrance on the first floor (fig.3d), butterflies, animal drawings, birds, doves, eagles, wings painted inside the ceiling of the shed entrance (fig.3e). Legendary animal drawings were painted and showed a legendary animal with an animal head and a plant body ending in a spiral shape (fig.2f). Plant drawings frequently showed wrapped branches ending in a spiral shape containing triple paper petals and ending with in a heart shape (fig.2g). Chalice-like leaves, Roman alakantes, sheets, equity, and Roman alanthimon, flower God, as bilateral and trilateral exchange, Quartet, Quintet, six, eight, and twelve Hill, grape leaves and his bunch of grapes, the vases out of branches, flowers, sunflowers appeared (fig.2h). Baroque and Rococo, the flower of the roman alrozet, trees, arabesque and half fans palm (fig2i,j). Architectural decoration also appeared in the roof of the School and decoration of frames used in dividing the bishop to spaces and specific regions within which the painters performs his decoration, featured quadrilaterals, Quintet, and forms of assistive devices, circuits, and plagues of the seas, the lobate, contracts, shapes of eight ribs, and forms of stellar dishes (fig.2k,l). Besides the above-mentioned decoration, other forms and decorations were represented at the ceiling as stick; flames and charges fees of cloudy skies were painted (fig.2m). In addition, some landscape represented by River Nile (fig.3n) or some ancient buildings as Sphinx and pyramids (fig.3q) and Shrines (fig.3r)<sup>(2)</sup>.

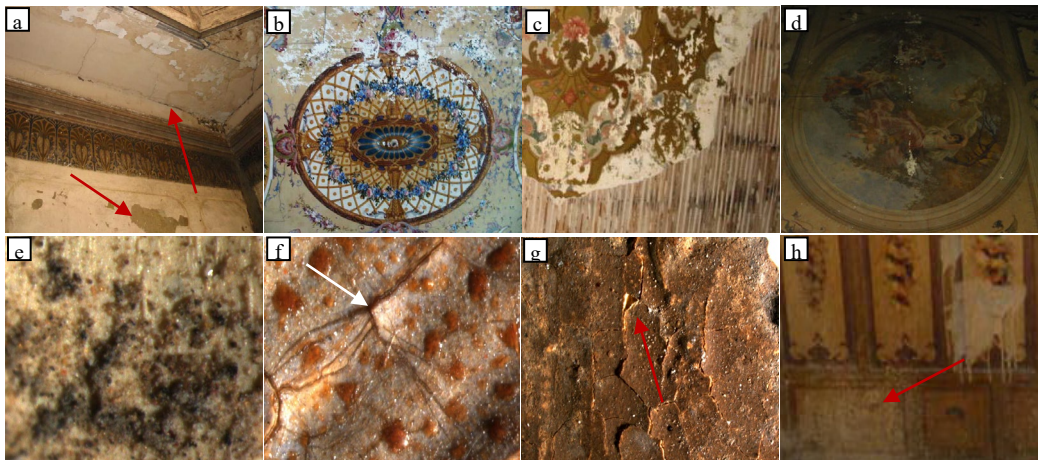
The wall paintings on the Krabia School are in a very bad condition. Physiochemical factors and biological agents play an important role in this deterioration causing remarkable amount of aesthetical and chemical damage. The most common alterations of the mural painting were is found in the paint layer as a result of moisture with constant water infiltration, due in part to failing roof drains; missing window panes and damaged impermeable roof membrane, the evaporation

front now migrates through the interior of the ceiling roof (fig.4a). Paint layer suffer from sever deterioration such as, detachment of the paint layer and some pieces were lost (fig.4b,c). Discoloration of the paint layer was noticed (fig.4d). Different types of dirt accumulate, such as dirt, dust, stains, insect's remains and house fly specks are deposited on the painting surface (fig.4e) which can cause the painting to deteriorate further and it is affect the painting visibility. In addition to crumbling in some parts of paint (fig.4f) and fine network of cracks is present through the paint and ground layers. Obviously salts effect can be seen (4g, h), widespread presence of salts, visible as a whitish irregular film in several places in Krabia School wall paintings, the nature of the salts has been determined by XRD and EDX analysis .

Figure 4: details of deterioration features of wall painting at Krabia School **a**: filtration of moisture from the ceiling **b**: **c**: detachment of the paint layer from the ground layer and other pieces of paint layer and ground layer were missing chromatic alterations **d**: discoloration of the paint layer **e**: dust, stains and insects remains **f**: crumbling in some parts of paint layer **g**: cracks and salt deposits at the paint layer.

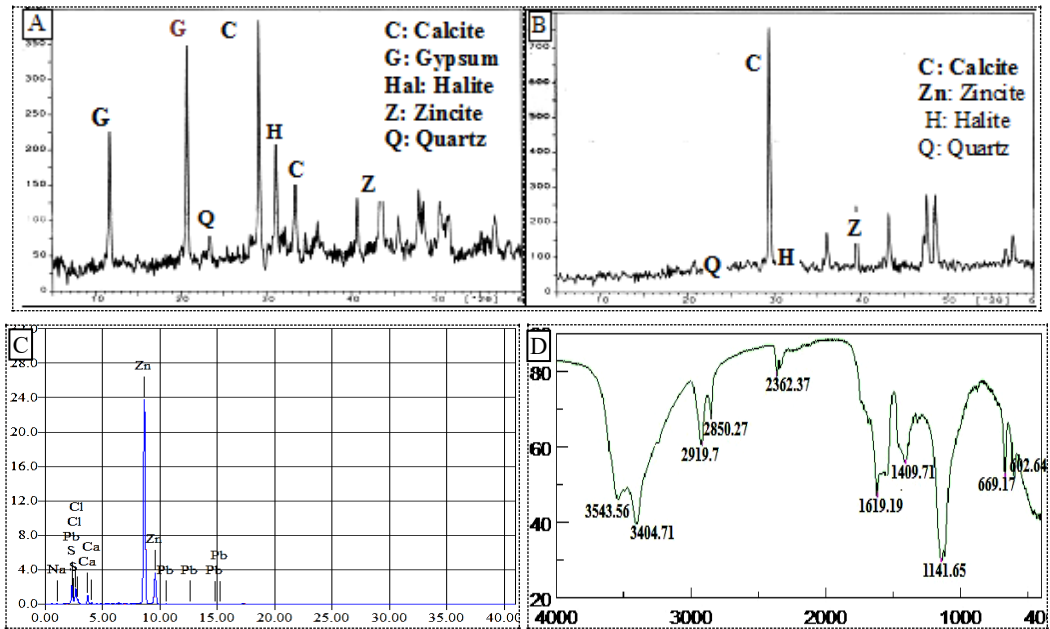
Figure: 7 a,b:, d: FT- IR pattern of preparation layer e: XRD pattern of coarse preparation layer, f: XRD pattern of fine preparation layer, g: SEM-EDX pattern of fine plaster.

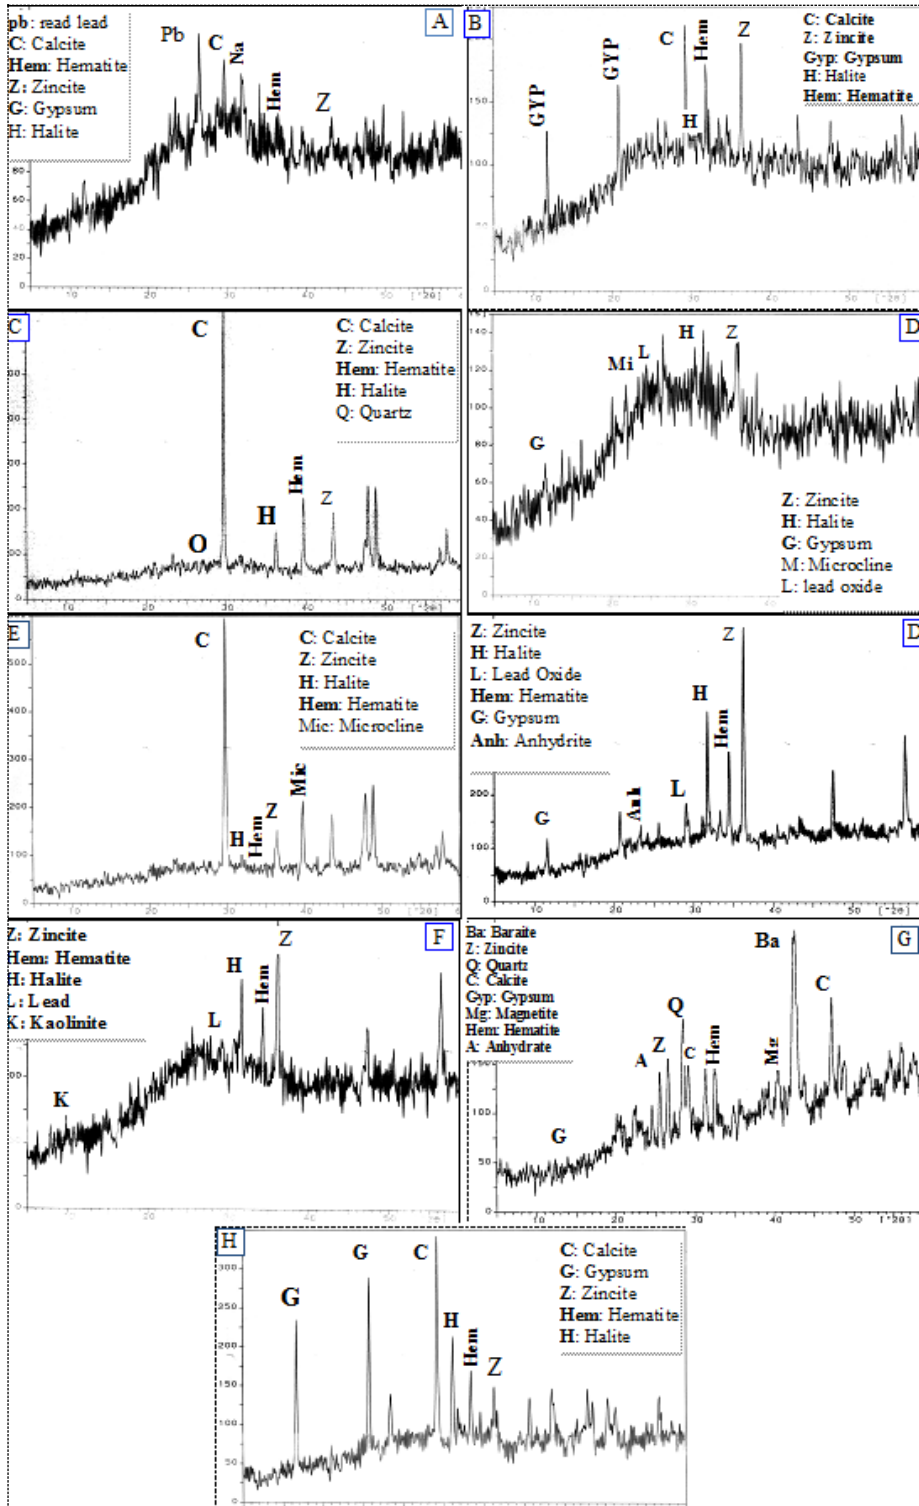
Figure 10: Shows XRD pattern of the paint layer of Krabia School **a** red color **b** brown color **c** pale brown **d** lemon yellow color **e** white color **f** orange color **g** pink color **h** olive green **h** beige color.
